MEASUREMENT OF CHARACTERISTICS
OF LIGHTNING AT HIGH ALTITUDES

Centre d'Essais Aeronautique de Toulouse

Translation of "Mesure des caracteristiques de la foudre en altitude",
Centre d'Essais Aeronautique de Toulouse, Toulouse, France, Test No.
76/650000 P. 4, May, 1979, 74 pages.

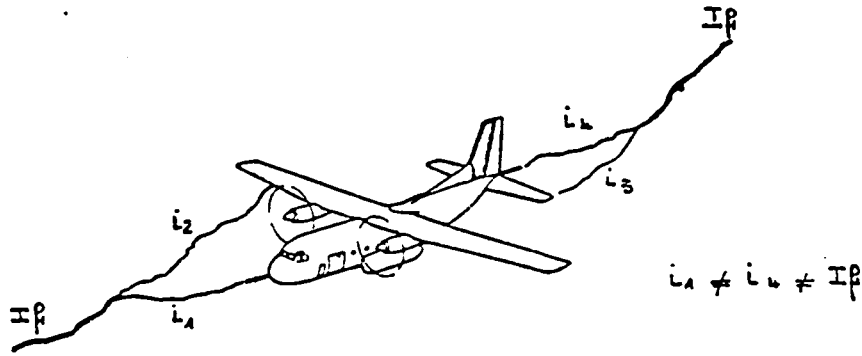
The peak currents recorded in the front and rear poles differed in certain cases by a factor of three even though qualitatively (ascent time, time from zero to I_{max} , descent time) they were identical.

This phenomenon stems from the fact that a flash of lightning has several branches, but only one of them passes through the rod:

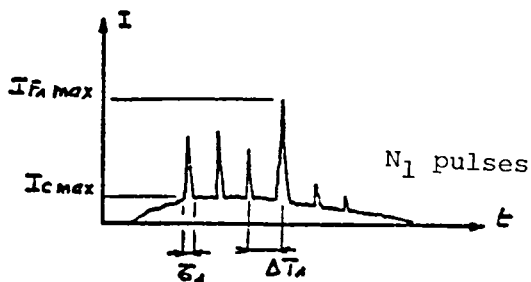
Type 1 Lightning Bolt Current (Total Number: 6)

The current takes the form of a group of N_1 pulses of duration τ_1 and separated by an interval ΔT_1 . They are superimposed on a small DC component of amplitude $I_{c \max}$.

$$\begin{aligned} I_{f1 \max} &\leq 4.5 \text{ ka} \\ 3 &< N_1 < 12 \\ 8 \text{ } \mu\text{s} &< \tau_1 < 200 \text{ } \mu\text{s} \end{aligned}$$

$$50 \mu s < \Delta T_1 < 200 \mu s, \text{ or } 5 \text{ kHz} < f_1 (\Delta T_1) < 20 \text{ kHz}$$

$$I_{c \text{ max}} < 2 \text{ ka}$$

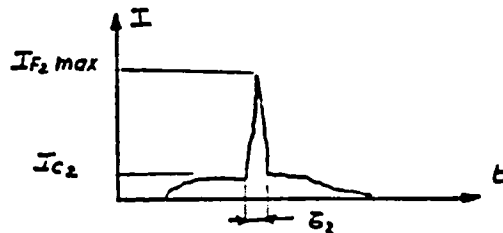
Type 2 Lightning Bolt Current (Total Number: 3)

The current takes the form of a single pulse^{se} of duration τ_2 superimposed on a DC component.

$$I_{f2 \text{ max}} \leq 70 \text{ ka}$$

$$I_{c2 \text{ max}} \leq 0.5 \text{ ka}$$

$$80 \mu s < \tau_2 < 200 \mu s$$

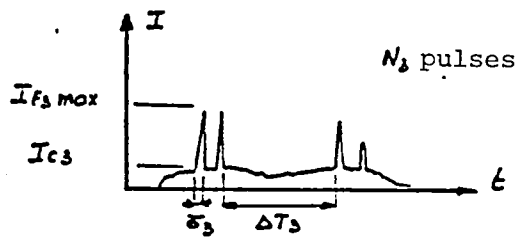
Type 3 Lightning Bolt Current (Total Number: 4)

The current takes the form of groups of pulses separated by a relatively large interval ΔT_3 .

$$1 < N_3 < 8$$

$$I_{f3 \text{ max}} \leq 50 \text{ ka}$$

$$20 \mu s < \tau_3 < 200 \mu s$$

$$50 \mu s < \Delta T_3 < 14 \text{ ms}$$

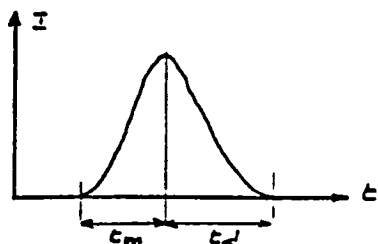
The pulses take the form of a practically symmetric double exponential curve. In the majority of cases $t_m \neq t_d$.

$$8 \leq \frac{t_m}{t_d} \leq 100 \mu s$$

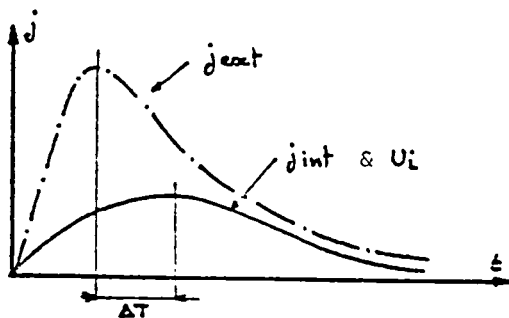
Variation in External and Internal Current Wave Form

- The effect of current diffusing across the airplane's skin. This phenomenon is expressed by an attenuation of the ascending part of the pulse, a shift in the maximum point, and a smaller current density on the internal wall than on the external one.

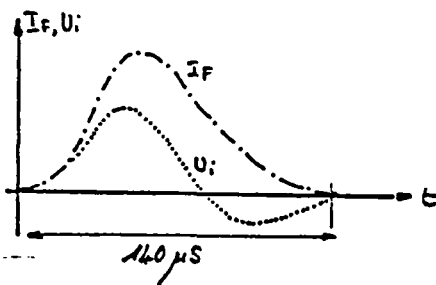
Diffusion of Little Significance
 dI/dt with Slight Delay
(Flight No. 5)

- that U_i lasts a shorter period of time than I_i in every case;
- that when $I_i(t)$ varies slowly, the contribution of the inductive effect (dI_i/dt) increases.

Examination of the oscillograms, plates 38 to 50, even though it is difficult to tell where time zero is, shows:

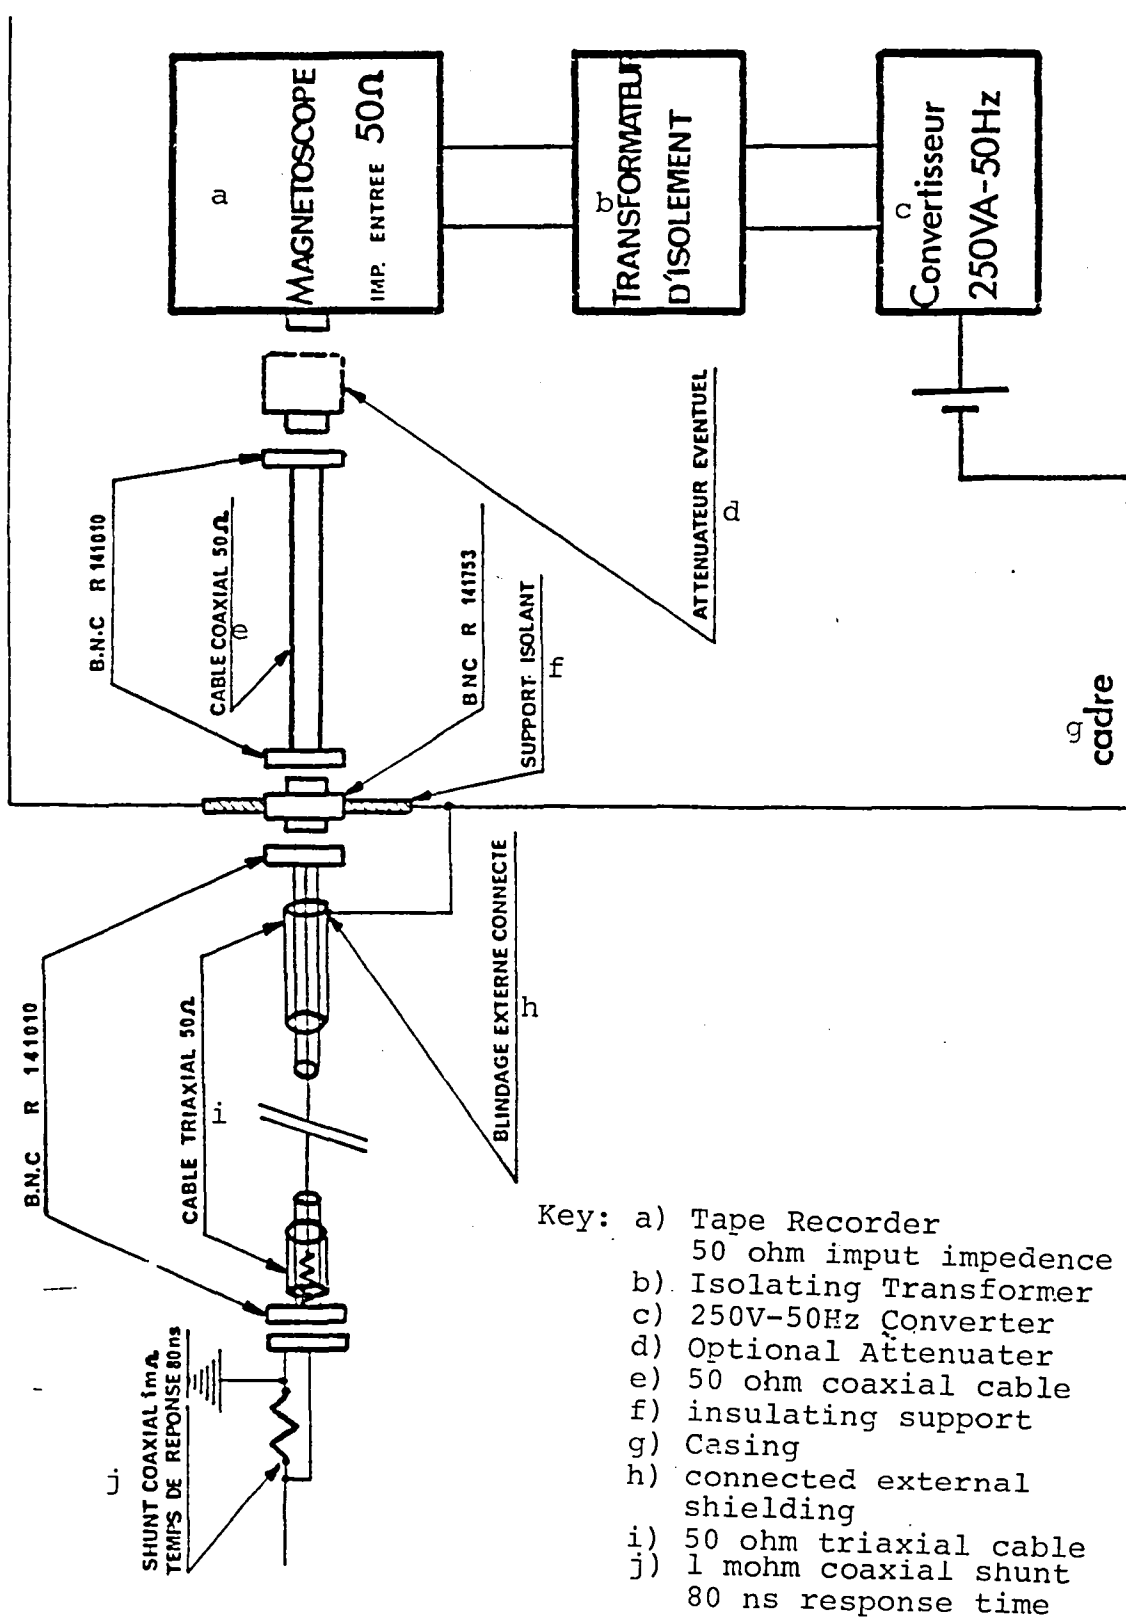
Plate 1

Lightning Bolt Current Measurement Circuitry

4.1 Measurement of Lightning Bolt Current (Plate 1)

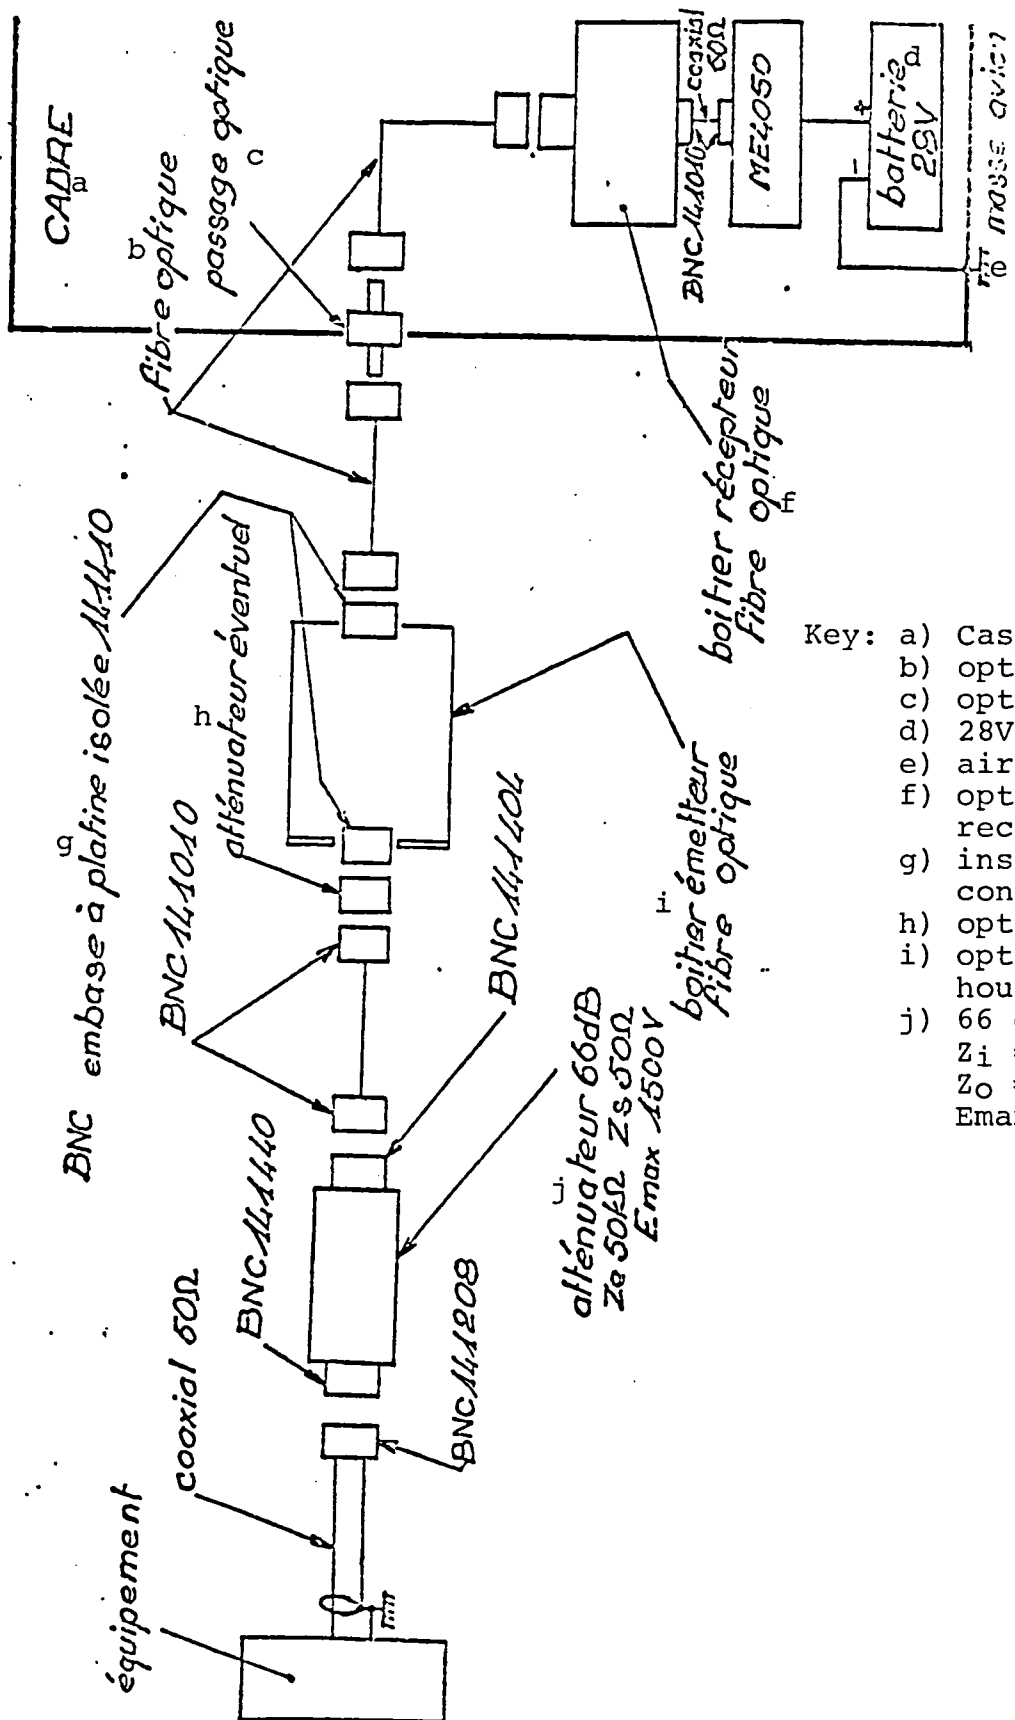
Lightning Surge Measurement by Optical Fiber

- Key:
- a) Casing
 - b) optical fiber
 - c) optical passage
 - d) 28V Battery
 - e) airplane body
 - f) optical fiber receiver housing
 - g) insulated platinum connector
 - h) optional attenuator
 - i) optical fiber emitter housing
 - j) 66 dB attenuator
 $Z_i = 50\text{ kohm}$
 $Z_o = 50\text{ ohm}$
 $E_{\text{max}} = 1500\text{ V}$

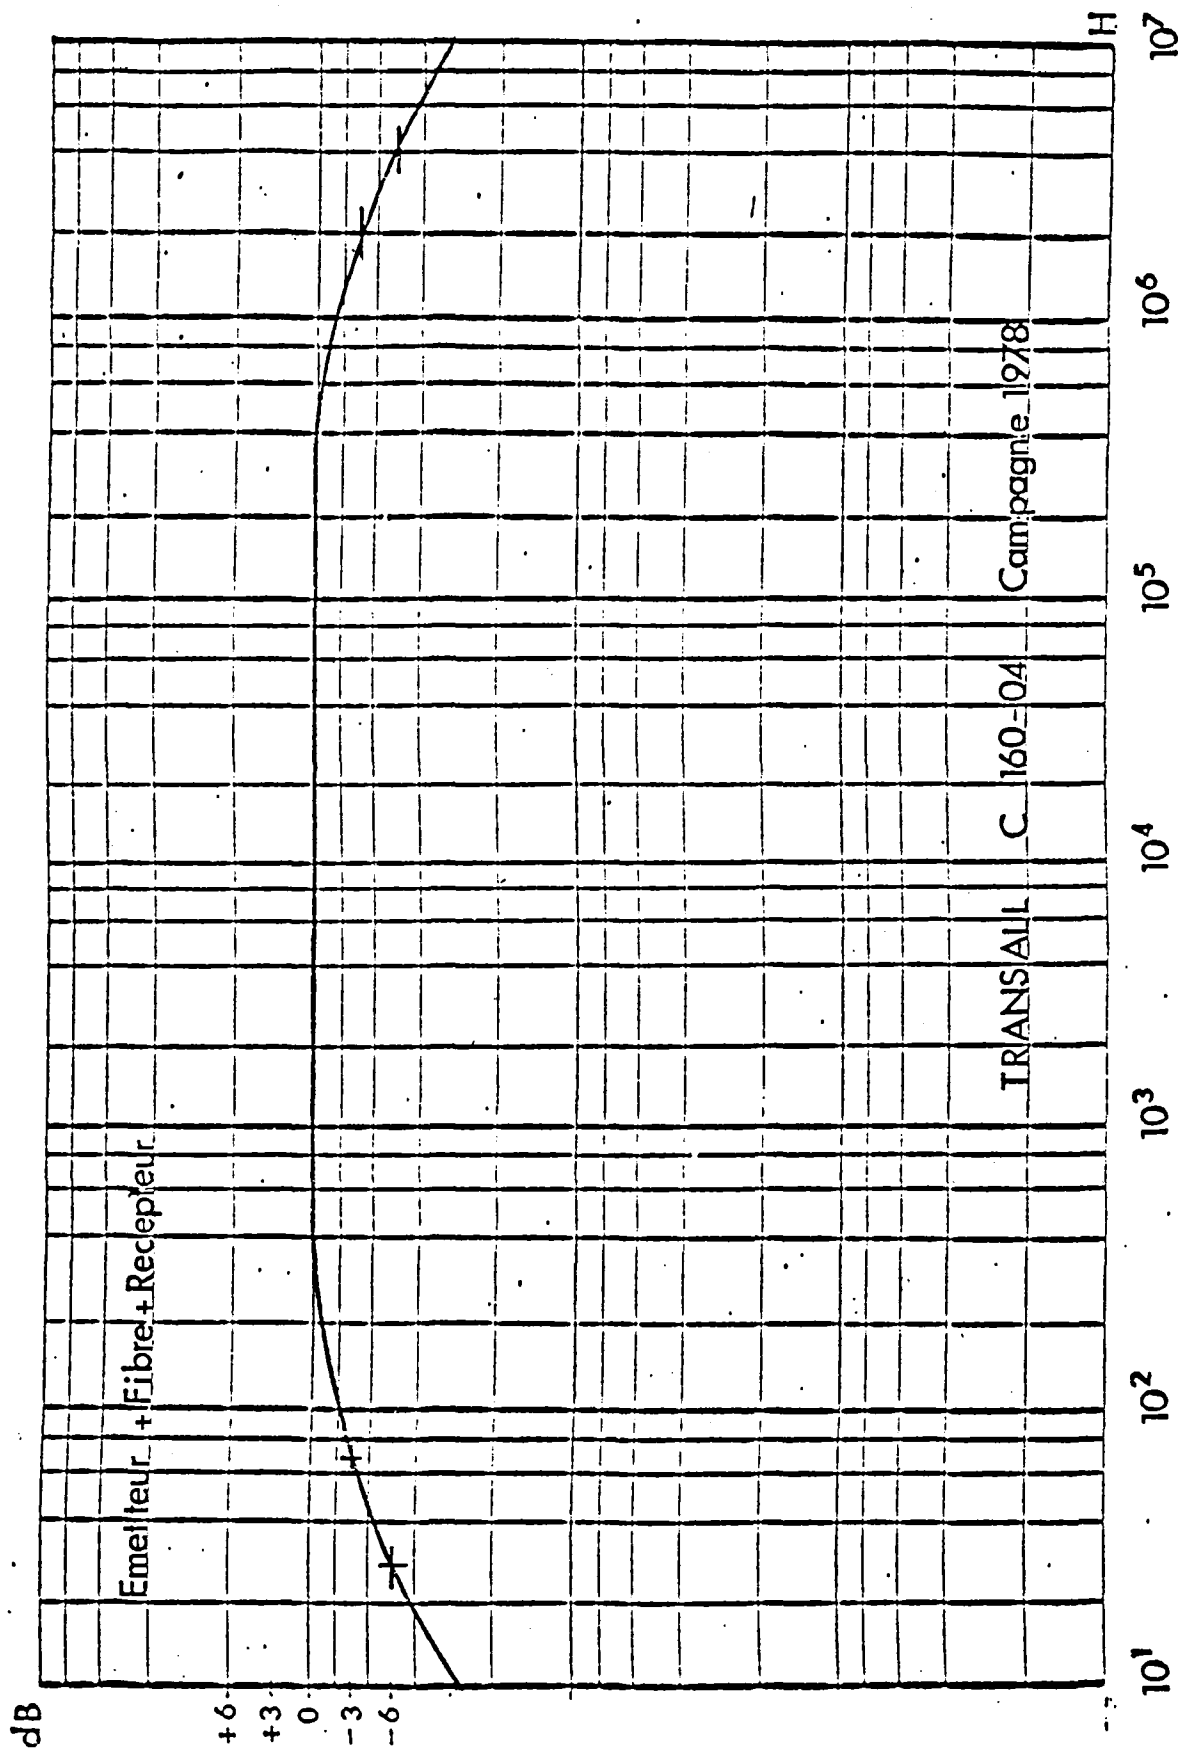
Emitter + Fiber + Receiver
1978 Transall Measurements

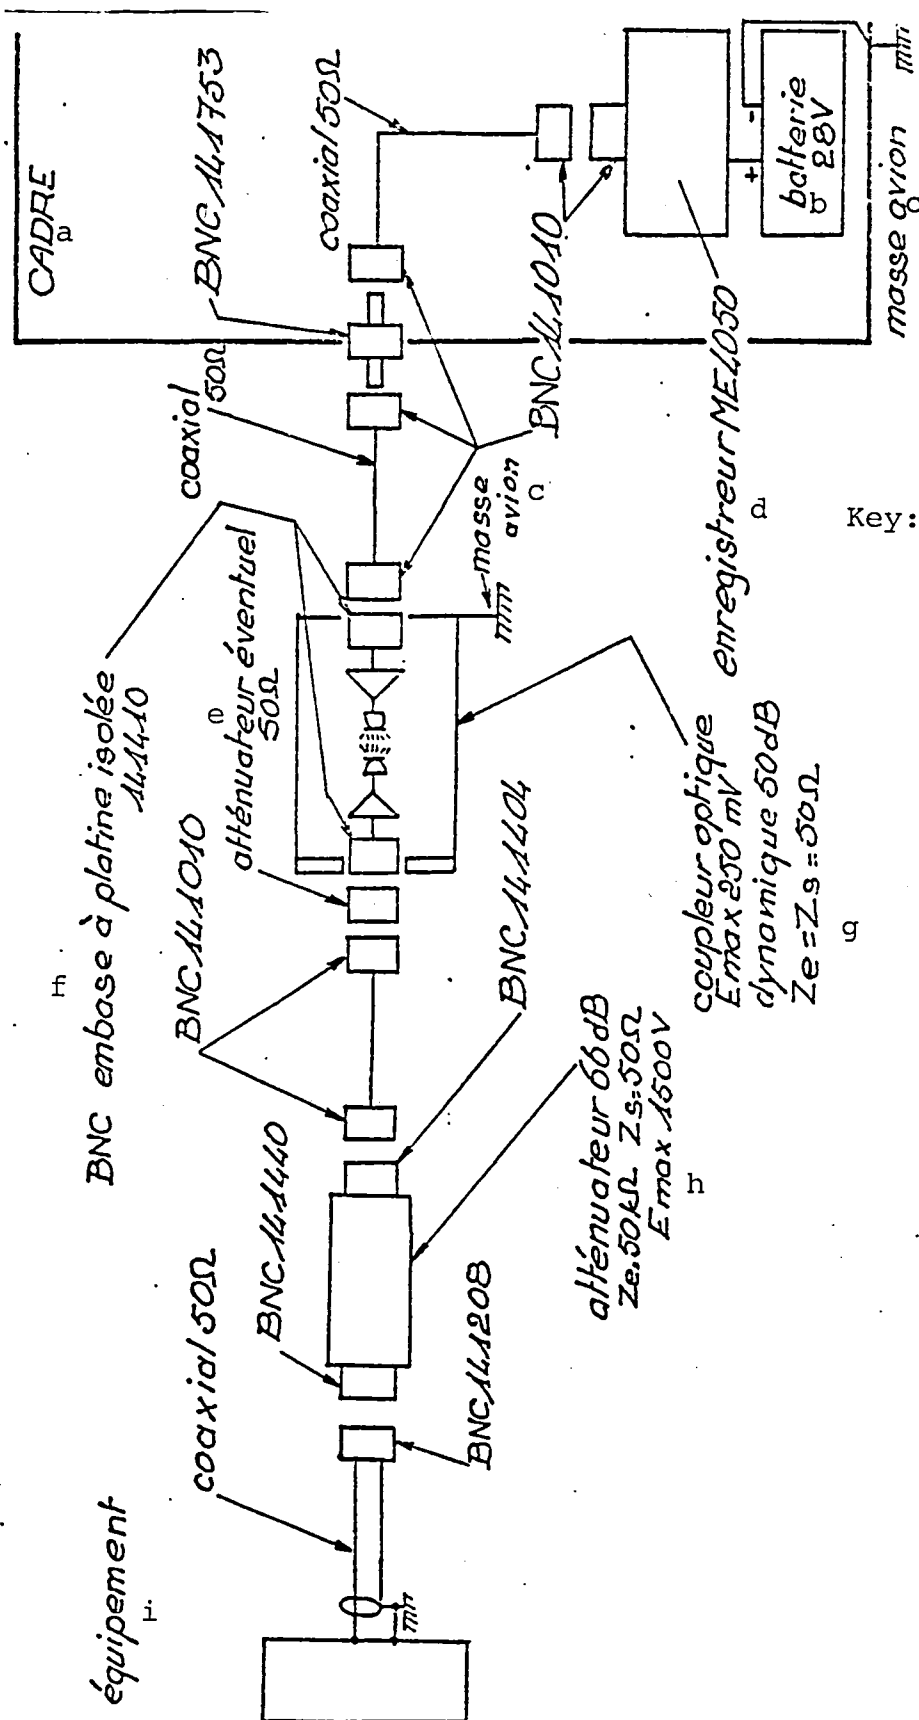
Lightning Surge Measurement by Optical Coupler

- Key:
- a) Casing
 - b) 28V battery
 - c) airplane body
 - d) ME4050 recorder
 - e) optional attenuator
 - f) insulated platinum connector
 - g) optical coupler
 $E_{max} = 250V$
 $50dB$ dynamic
 $Z_i = Z_o = 50 \text{ ohms}$
 - h) 66 dB attenuator
 $Z_i = 50k\Omega$ $Z_o = 50\Omega$
 $E_{max} = 1500V$
 - i) equipment

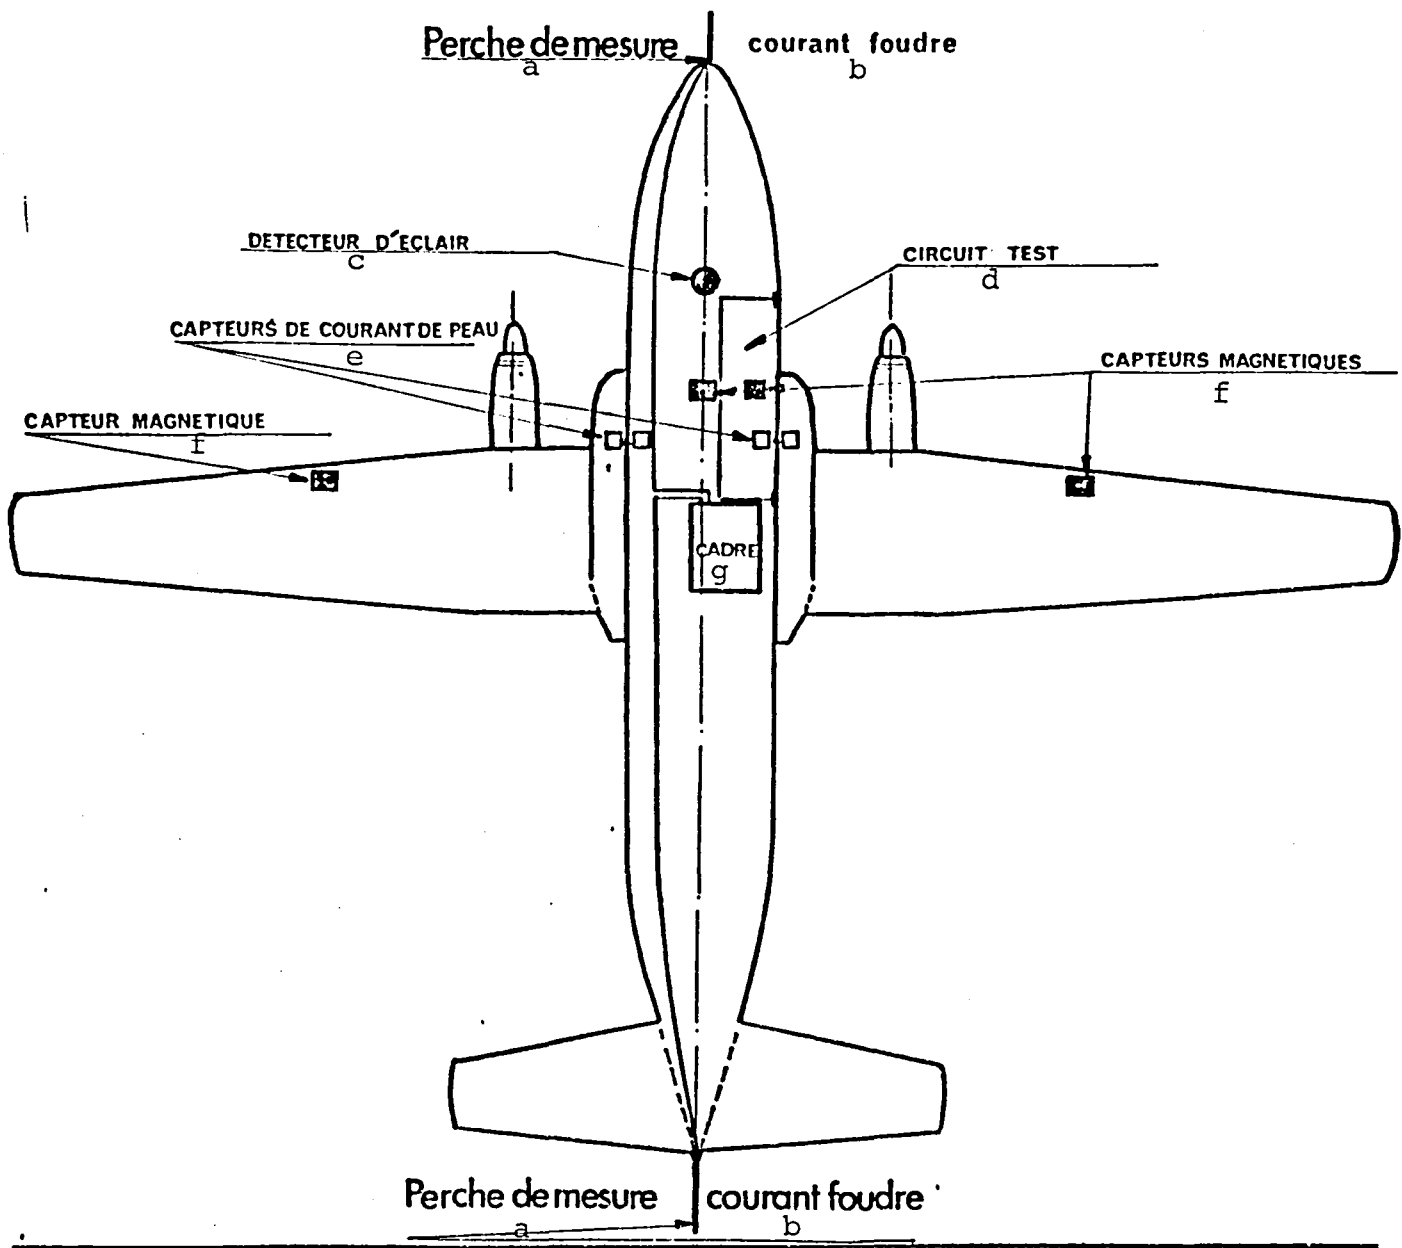
Plate 7

Description of Lightning Bolt Current

Key: a) Measuring Rod
 b) Lightning Bolt Current
 c) flash detector
 d) test circuit
 e) skin current sensor
 f) magnetic sensor
 g) shielded enclosure

Plates 7 and 8 give an overall view of the special measurement equipment used in describing lightning bolts and their indirect effects.

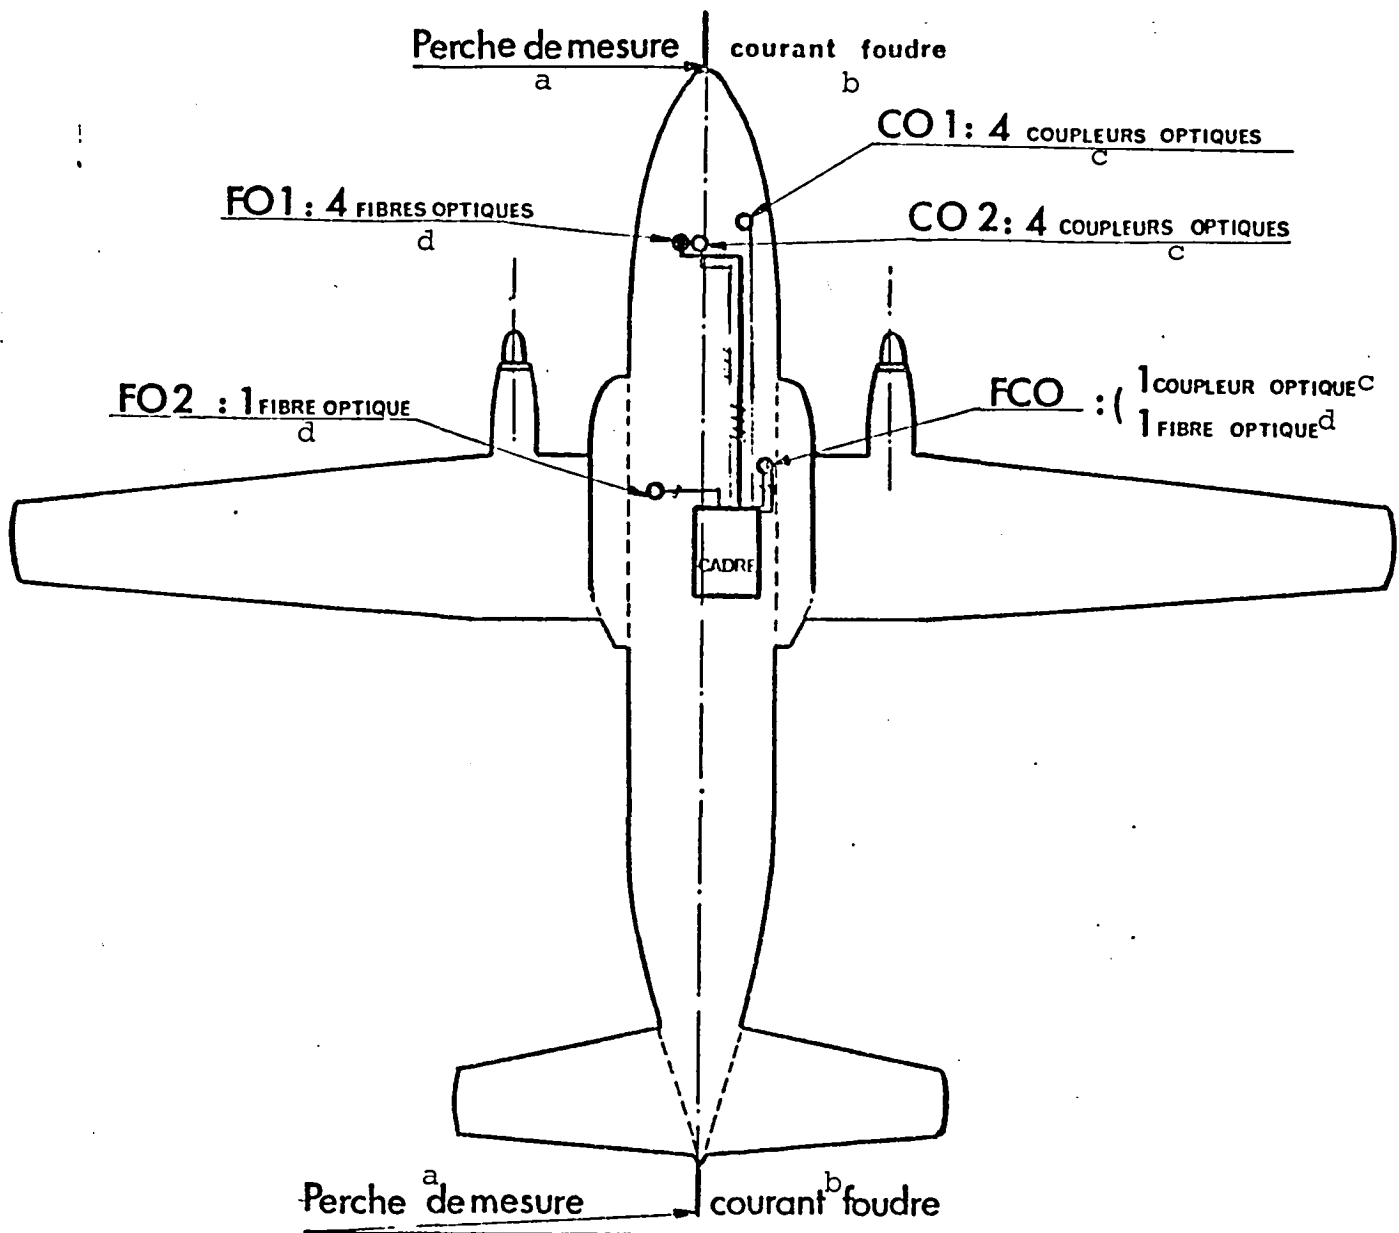
Position of Lightning Surge Measurement Emitter Housings

Key: a) Measuring Rod
 b) Lightning Bolt Current
 c) optical coupler(s)
 d) optical fiber(s)

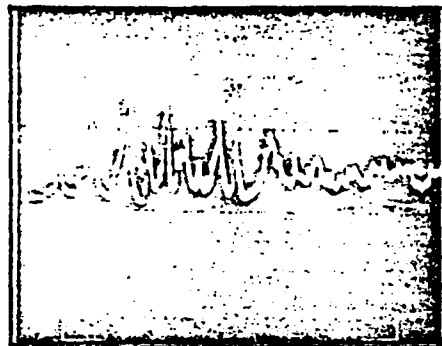
Vert. Scale: 200mV/c

or 4 kA/c

Horiz. Scale: 100μs/c

Plate 19 shows a typical lightning discharge of this type.

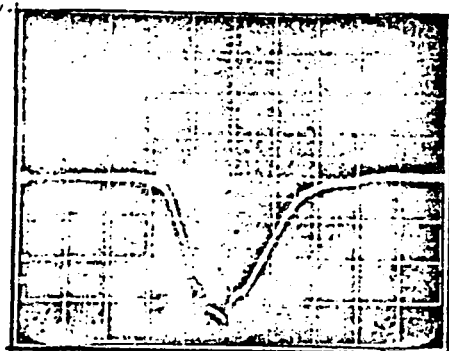
Vert. Scale: $200 mV / c$

or $8 kA / c$

Plate 21 shows a typical lightning discharge of this type.

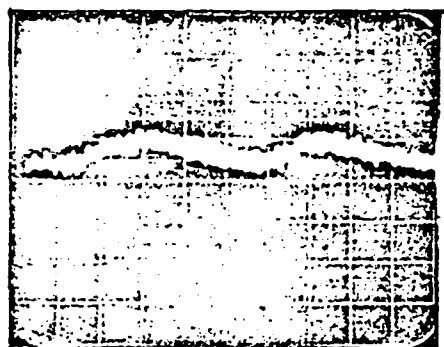
Détail A

Horiz. Scale: 10μs/c

Vert. Scale: 100mV/c

or 4 kA/c

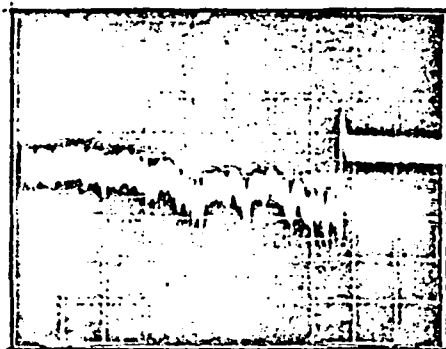
Vert. Scale: 50mV/c

or 2 kA/c

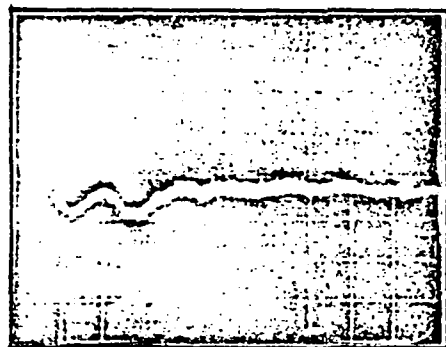
Détail A

Horiz. Scale: 100μs/c

Vert. Scale: 50mV/c

or 2 kA/c

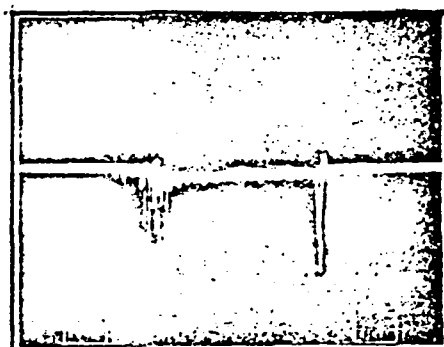
Vert. Scale: 500mV/c

or 20 kA/c

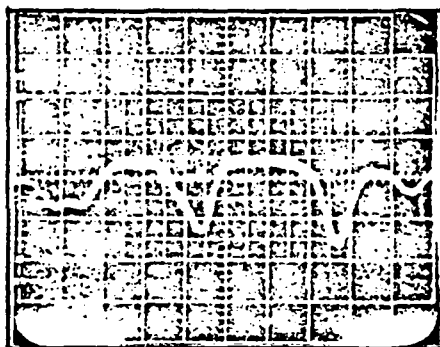
Détail A

Vert. Scale: 500mV/c

or 20 kA/c

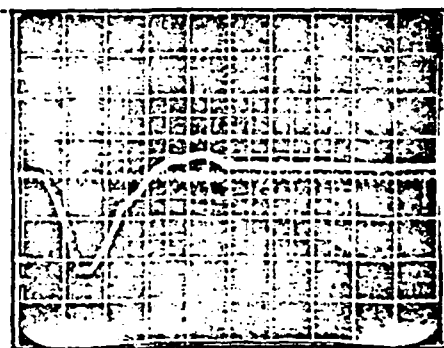
Détail B

Horiz. Scale: 50μs/c

Vert. Scale: 500mV/c

or 20 kA/c

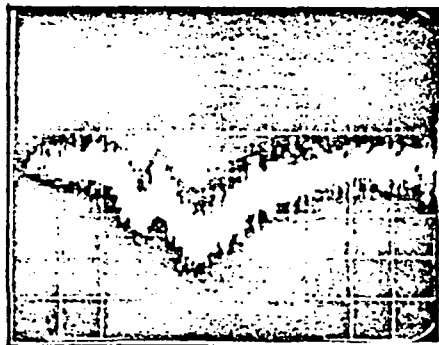
Détail A

Horiz. Scale: 50μs /c

Vert. Scale: 50mV/c

or 2 kA/c

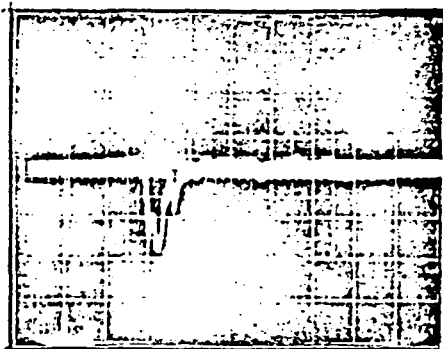
Vert. Scale: 100mV/c

or 4 kA/c

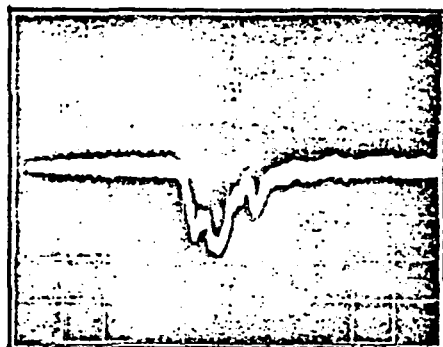
Détail A

Horiz. Scale: 0,2ms/c

Vert. Scale: 100mV/c

or 4 kA/c

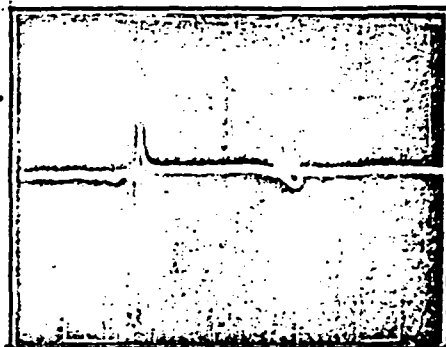
Vert. Scale: 0,5V/c

or 20 kA/c

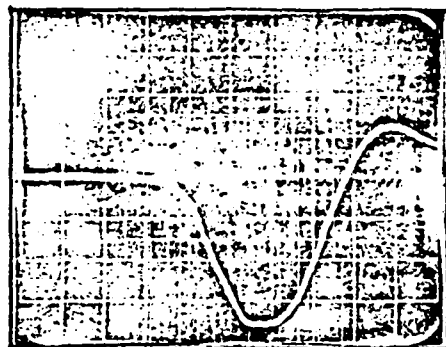
Détail A

Horiz. Scale: 20μs/c

Vert. Scale: 0,5V/c

or 20 kA/c

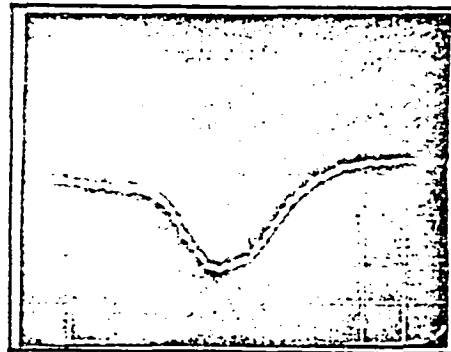
Détail A

Vert. Scale: $0.2 / c$

or kA / c

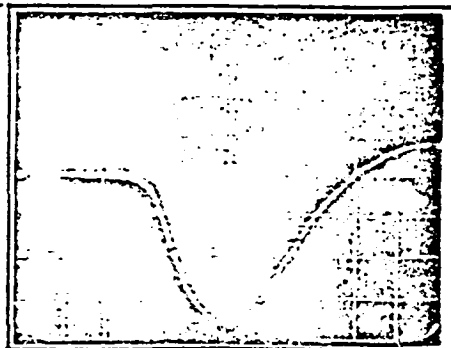
Détail B

Horiz. Scale: $20 \mu s / c$

Vert. Scale: $0.2 V / c$

or kA / c

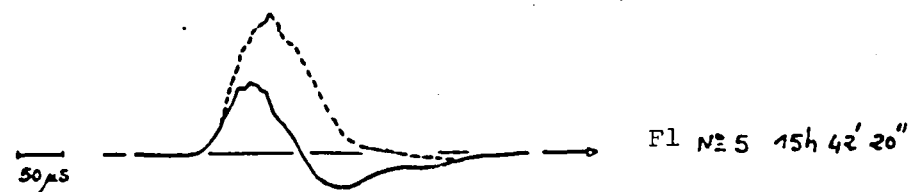
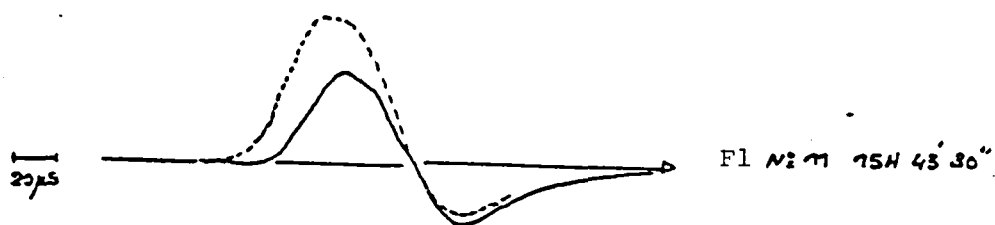
Plate 51

Comparison of Front Rod Lightning
Current with Test Line Voltage

..... Lightning Bolt Current
_____ Induced Voltage V_i

In contrast, the current-induced voltage superposition analysis performed in plate 51 shows that the inductive effect is never dominant.

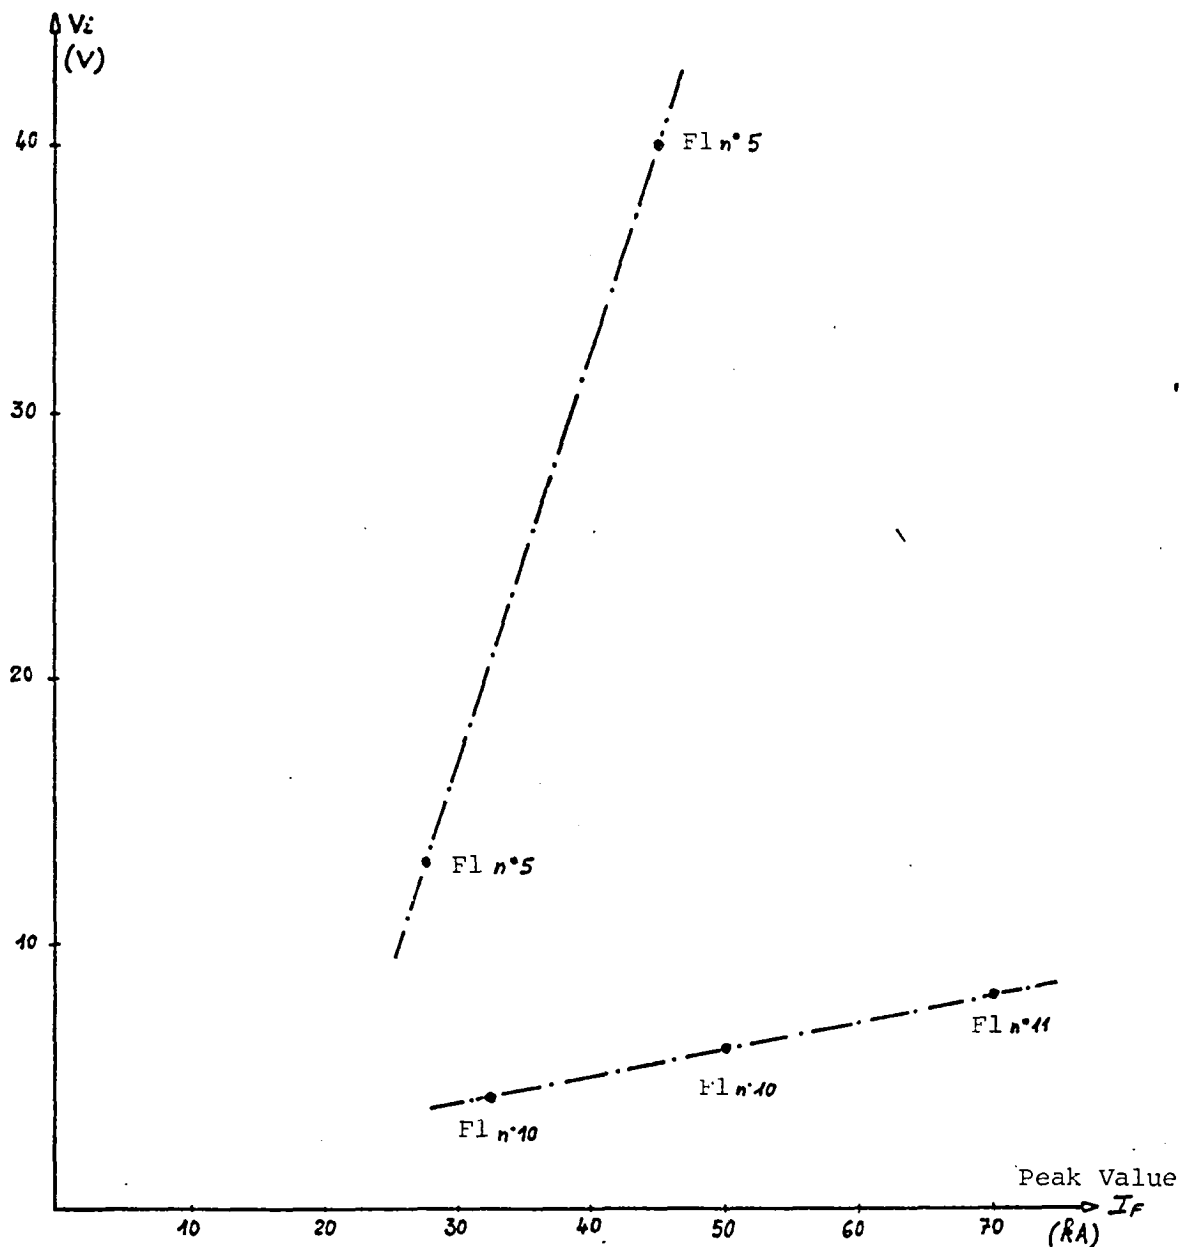
Voltage V_i Induced on the Test
Line as a Function of the Peak
Value of Lightning Bolt Current I_F
